# Environmental Exposure Report

## Depleted Uranium in the Gulf

Last Update: July 31, 1998

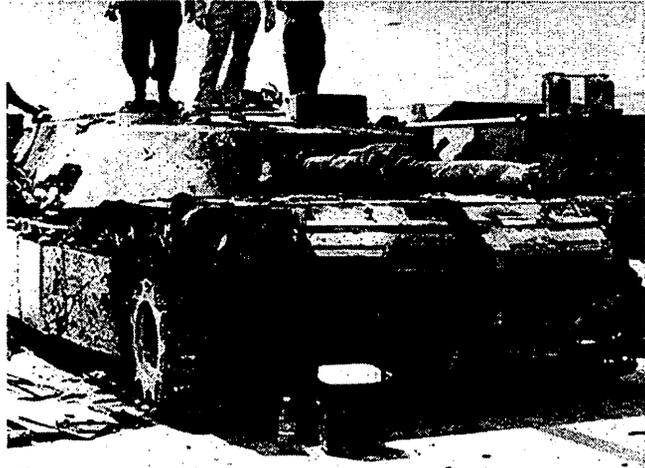
EOD and RADCON personnel also played key roles in responding to the post-war (July 11, 1991) Camp Doha motor pool fire in which three M1A1 tanks uploaded with M829 DU sabot rounds were destroyed, as well as several hundred DU rounds stored nearby. Cleanup efforts in Camp Doha’s motor pool area (the North Compound) also exposed several hundred troops to residual DU contamination in the vicinity of the burned tanks and ammunition conexes (see Tab I for a description of the Doha fire and cleanup): EOD personnel also entered DU-contaminated enemy combat vehicles with greater frequency and duration than other troops. These activities exposed the troops involved to contact with “resuspended”

Figure 8 – RADCON personnel atop M1A1 hulk.

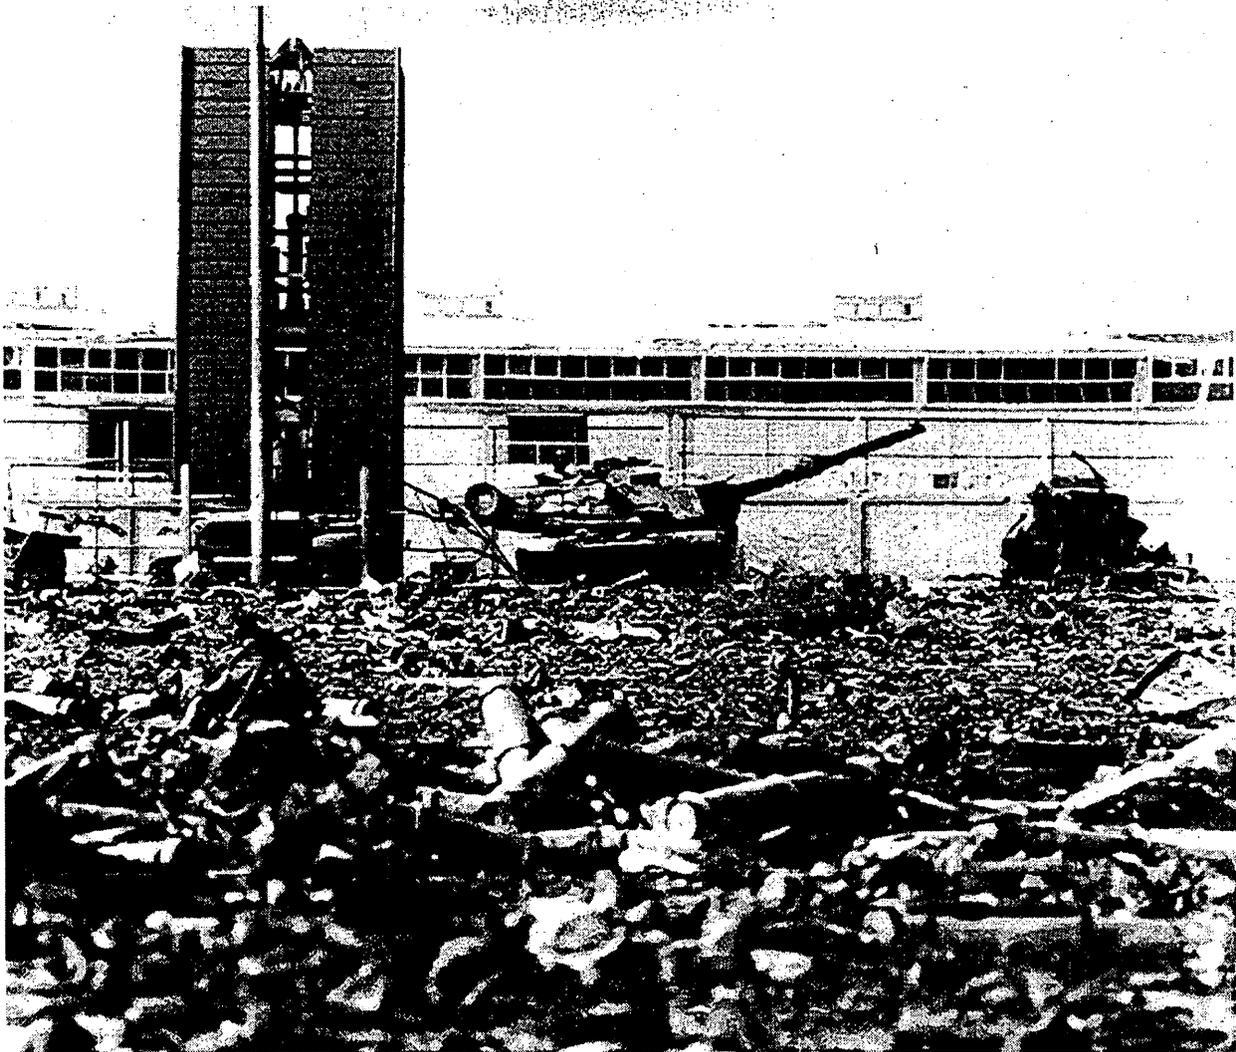
Figure 29 - Aftermath of Doha motor pool fire (view of washrack area) showing armor hulks and UXOs.

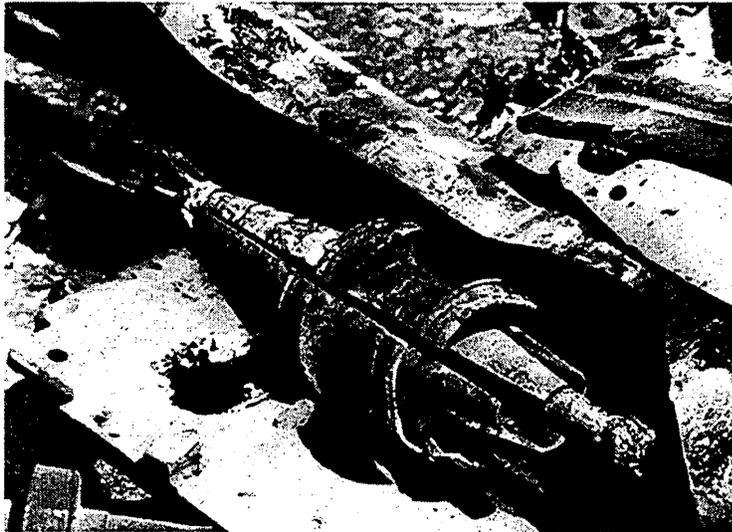
Figure 30 - Burned DU rod and sabot

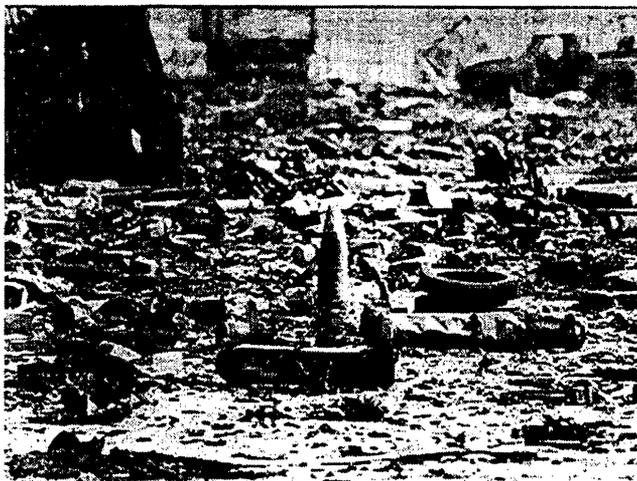
Figure 36 - UXOs in Doha's North Compound

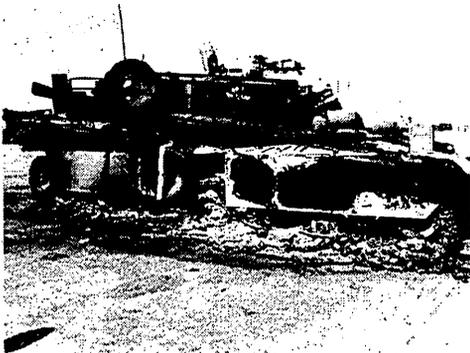
All four of the M1A1s were damaged/destroyed as a result of fires external to the vehicle. *There were no penetrations anywhere of the exterior armor* (emphasis added). Three of the four M1A1s had their fuel and ammunition destroyed. In these three cases, there was an explosion in the ammunition compartment. The ammunition doors and blowout panels functioned properly, keeping the blast from entering the crew compartment. The fourth M1A1 was damaged on the right suspension only, and except for the gunner's computer and transmission warning lights, was completely operational.<sup>251</sup>

Figure 40 - Burned-out Doha M1A1

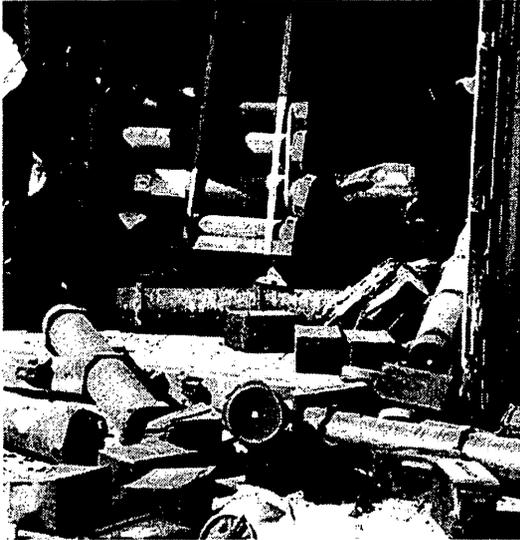
Figure 44 - Unexploded DU rounds
