**AIRCRAFT  
ACCIDENT INVESTIGATION BOARD  
REPORT**

**US ARMY UH-60  
BLACK HAWK HELICOPTERS  
87-26000 AND 88-26060**

**TECHNICAL OR ENGINEERING EVALUATIONS**

AMSEL-RD-NV-SE-EWD (SFAE-AV-AEC/25 Apr 1994) (70-1r) 1st End  
Mr. R. Paolella and Ms. P. Lum/x44697 and x43211  
SUBJECT: Failure Analysis on Crash Damaged Electronic Equipment

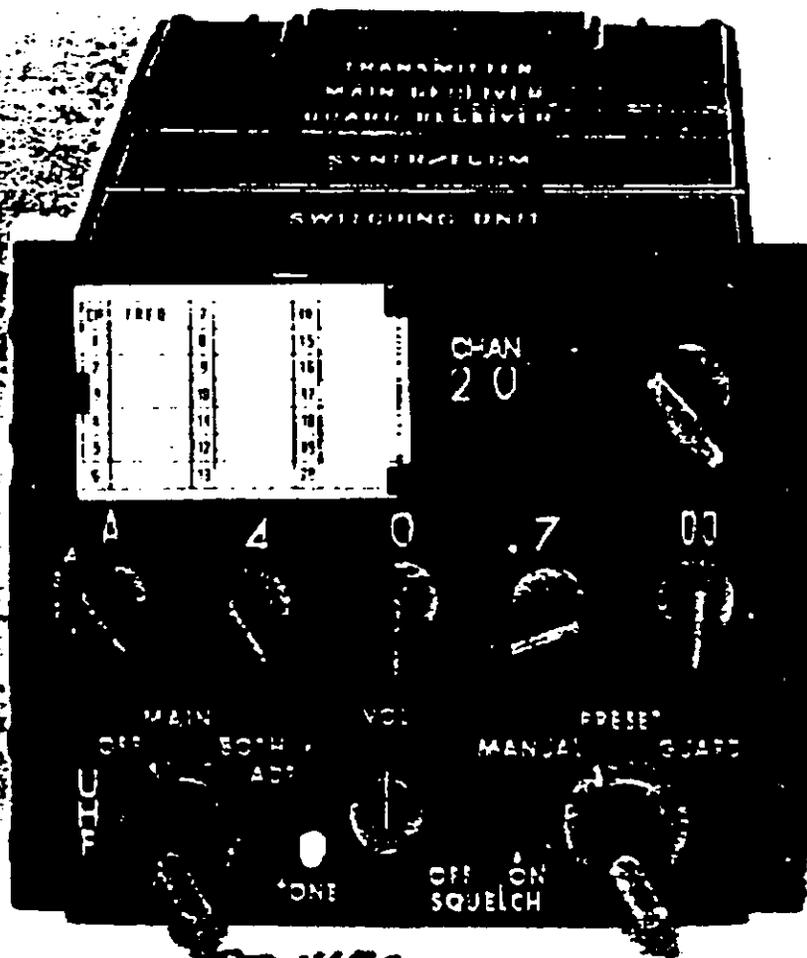
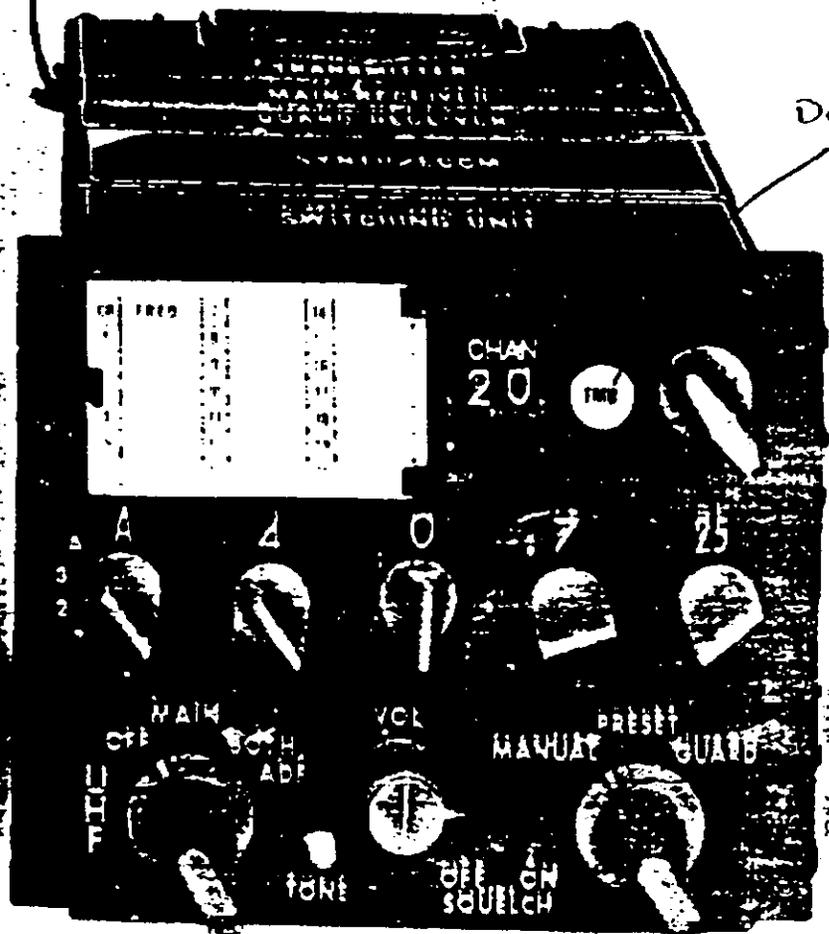
ARC-164 Comparison *White Triangle*

a. The RT-1167 faceplate is of different construction than the RT-1168 faceplate. The RT-1167 faceplate has grommets and a different channel selector switch which enables it to be rain-proof. The RT-1167 actually gets a rain test in the factory. The RT-1168 gets humidity testing only, no rain.
