# Environmental Exposure Report

## Depleted Uranium in the Gulf

Last Update: July 31, 1998

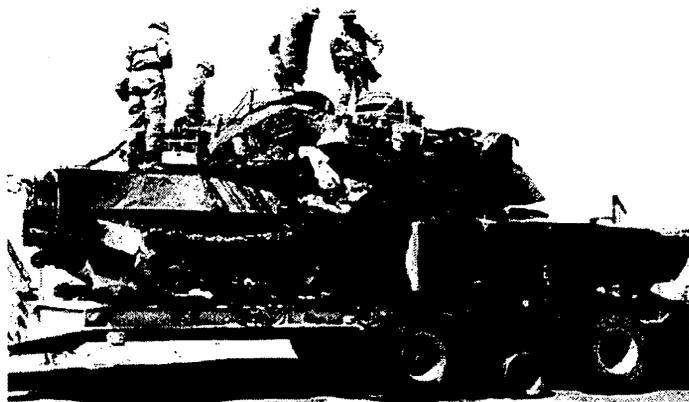
Eight friendly fire incidents involving DU munitions are known to have occurred during the Gulf War. These incidents (distinct from non-DU friendly fire incidents or cases where friendly vehicles were evacuated and then deliberately destroyed to prevent their capture) resulted in the contamination of six M1/M1A1 tanks and 15 Bradley Fighting Vehicles. Another M1A1 was hit by a large shaped-charge round, believed to be a Hellfire missile fired from an Apache

Figure 22 - M1A1 lost to friendly fire

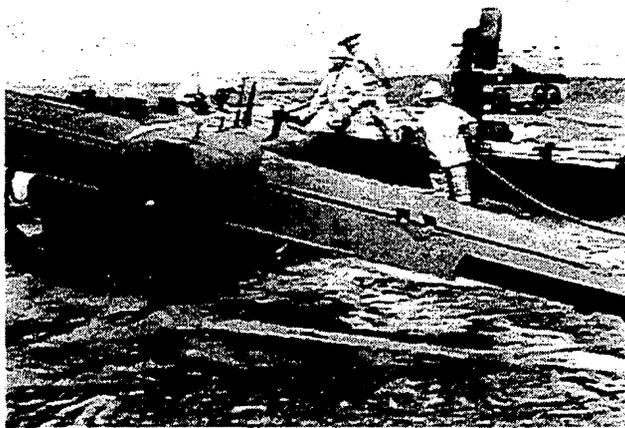
An A-10 aircraft reportedly crashed and burned while trying to recover at KKMC.<sup>138</sup> The crash could have exposed emergency response personnel (firefighters; security policemen, rescue personnel) to smoke and DU oxides from burning 30mm DU rounds carried as part of the A-10's combat ammunition load. In addition, cleanup crews might have been exposed as well, if they did not wear proper personal protective equipment. This case is under investigation.

Figure 23 – Crashed A-10 at KKMC

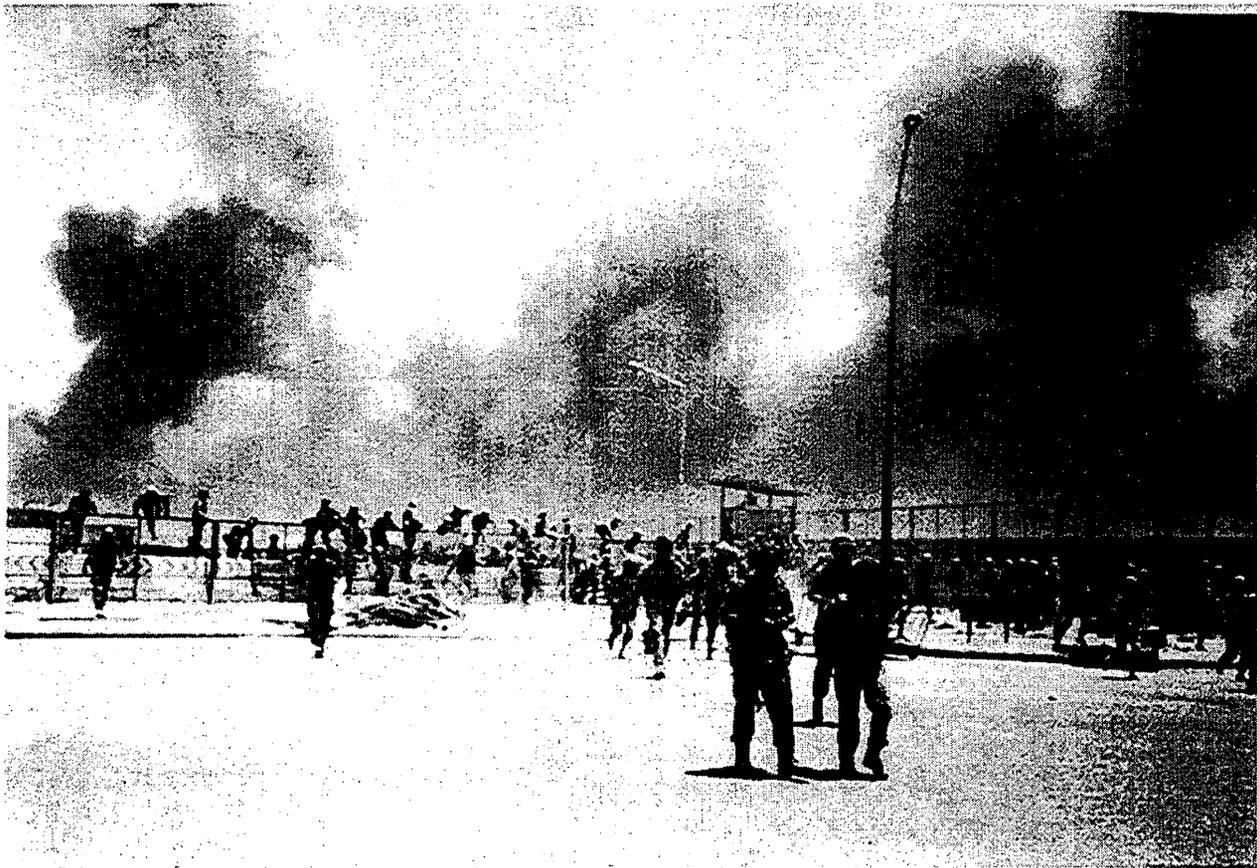
The fires had died down enough by mid-afternoon to allow a preliminary damage assessment. There were no fatalities; however, 49 US soldiers were injured, two seriously. Most of the injuries were fractures, sprains, contusions, or lacerations suffered when troops scrambled over the 15-foot high perimeter wall to escape the North Compound (Figure 28).<sup>198</sup> In addition, four British troops received minor injuries.

Figure 28 - 11th ACR troops evacuate Doha's North Compound, July 11, 1991.

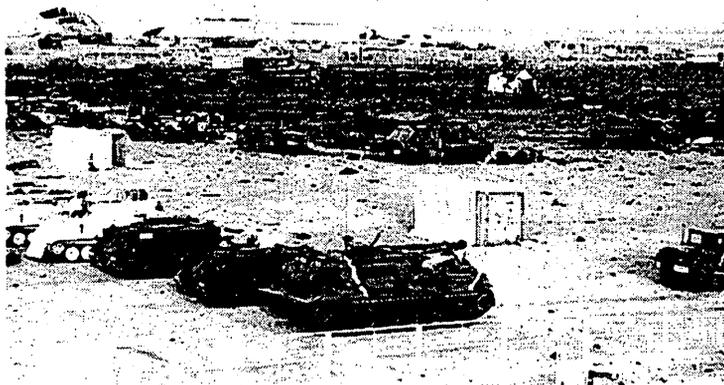
The post-blast destruction was overwhelming. One hundred and two vehicles were damaged or destroyed, including four M1A1 tanks and numerous other combat vehicles. More than two dozen buildings sustained damage as well.<sup>199</sup> Among the estimated \$14 million in munitions that had been damaged or destroyed were 660 M829 120mm DU sabot rounds.<sup>200</sup>

Figure 31 – Aftermath of Doha motor pool fire

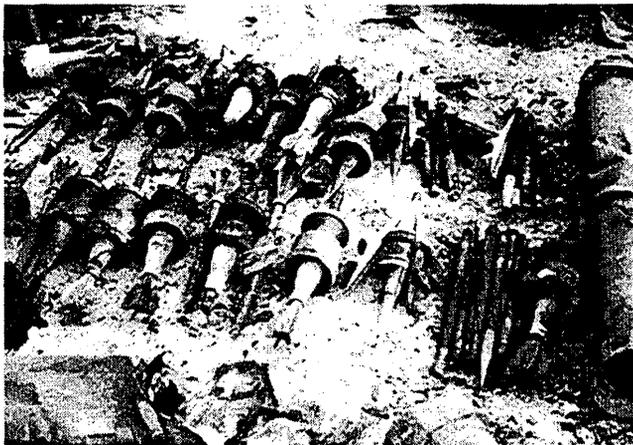
Figure 33 - DU rods collected at Doha

EOD troops were aware of the presence of DU and were familiar with the potential hazard that it posed. More importantly, they were trained and equipped to detect DU contamination. Their initial survey, which was limited due to the quantity of UXOs in the North Compound, found very little DU outside the immediate vicinity of the three destroyed tanks.<sup>221</sup> The standard uniform for UXO clearing was a flak jacket and kevlar helmet, with gloves worn when debris was moved. Because of the extreme heat, only T-shirts were worn under the flak vests. EOD and combat engineer troops (and later, line

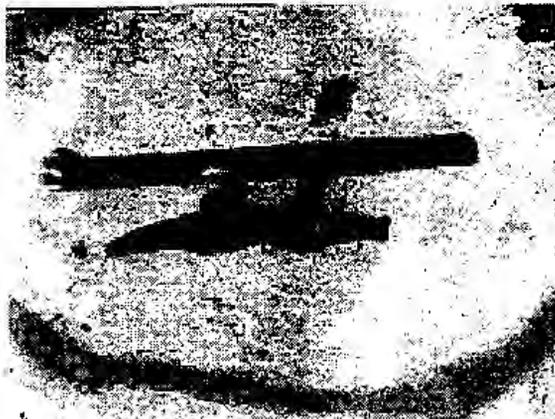
Figure 35 - Marked DU rod and sabot

The cleanup plan for the North Compound involved EOD personnel working together with the 58th Combat Engineering Company to find, mark, render safe, and remove UXOs. The former 146<sup>th</sup> Ord. Det. (EOD) Commander states that "Engineers didn't pick up any DU unless an EOD guy told them to." EOD marked the DU rounds they found with orange spray paint, painting a circle around the penetrator, and wore leather gloves to pick them up. Exposed DU penetrators were wrapped in heavy plastic and put in wooden boxes or 55-gallon drums. Later, after the AMCCOM Radiation Control team had arrived at Doha, the DU was placed inside one of the destroyed tanks for

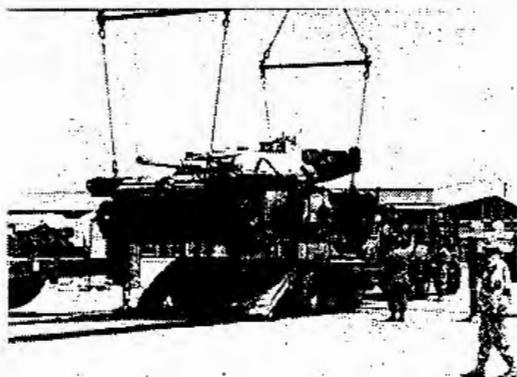
Three 55-gallon drums containing DU penetrators and a separate pile of burned penetrators were placed into the three contaminated tanks for shipment to the US. Seven M8A1 Chemical Agent Alarm Systems containing Americium-241 were also involved in the fire. One was recovered from the area cleared by EOD. The radioactive source cell was not damaged. One additional M8A1 was recovered from one of the M1A1 tanks removed from the area near the wash rack. The radioactive source cell was penetrated by a fragment from the explosion and burned in the fire. No alpha radiation

Figure 42 - Removing burned MIA1
