**AIRCRAFT  
ACCIDENT INVESTIGATION BOARD  
REPORT**

**US ARMY UH-60  
BLACK HAWK HELICOPTERS  
87-26000 AND 88-26060**

**TECHNICAL OR ENGINEERING EVALUATIONS**

AMSEL-RD-NV-SE-EWD (SFAE-AV-AEC/25 Apr 1994) (70-1r) 1st End  
Mr. R. Paolella and Ms. P. Lum/x44697 and x43211  
SUBJECT: Failure Analysis on Crash Damaged Electronic Equipment

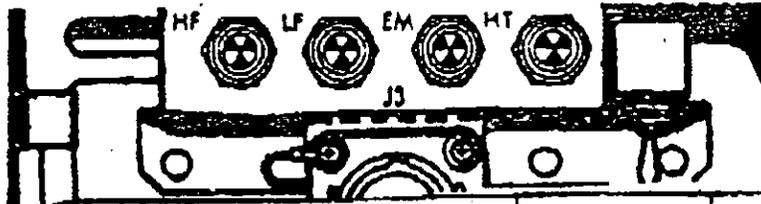
2. The only component of the AN/ALQ-144(V) IRCM that was delivered to NV&ES Directorate was the transmitter assembly, for failure analysis. The other major components, such as the operator control unit (OCU), and transit/carrying cases, were not delivered. The transmitter was so badly burnt and damaged, even though intact, that a failure analysis could not be made other than to say that with all the 4 Built In Test (BIT) indicators not tripped (normal operation), meant that the system experienced an instantaneous total failure of electrical power or the system may not have been turned on. This could only be verified by the position of the ON/OFF switch of the OCU which was not available and also by the setting of the IRCM circuit breakers located in the A/C cockpit. See the photo of BIT indicators of the transmitter upon receipt and the BIT functions NORMAL versus FAILURE shown below:

Indicator	Function	Normal	Malfunction
HF	Indicates whether the high frequency modulator is operating properly.	HIGH FREQUENCY 	
LF	Indicates whether the low frequency modulator is operating properly.	LOW FREQUENCY 	
EM	Indicates whether the source temperature is within the proper range.	EMISSION 	
HT	Indicates whether the transmitter operating temperature is within the proper range.	HIGH TEMPERATURE
