# AIRMUNITIONS LETTER

OCAMA AIRMUNITIONS LETTER  
NO. 136-11-56C

SUBJECT: Advance Explosive Ordnance Disposal Technical Information

SUMMARY OF NUCLEAR WEAPONS INCIDENTS (AF FORM 1058) AND  
RELATED PROBLEMS JUNE 1960

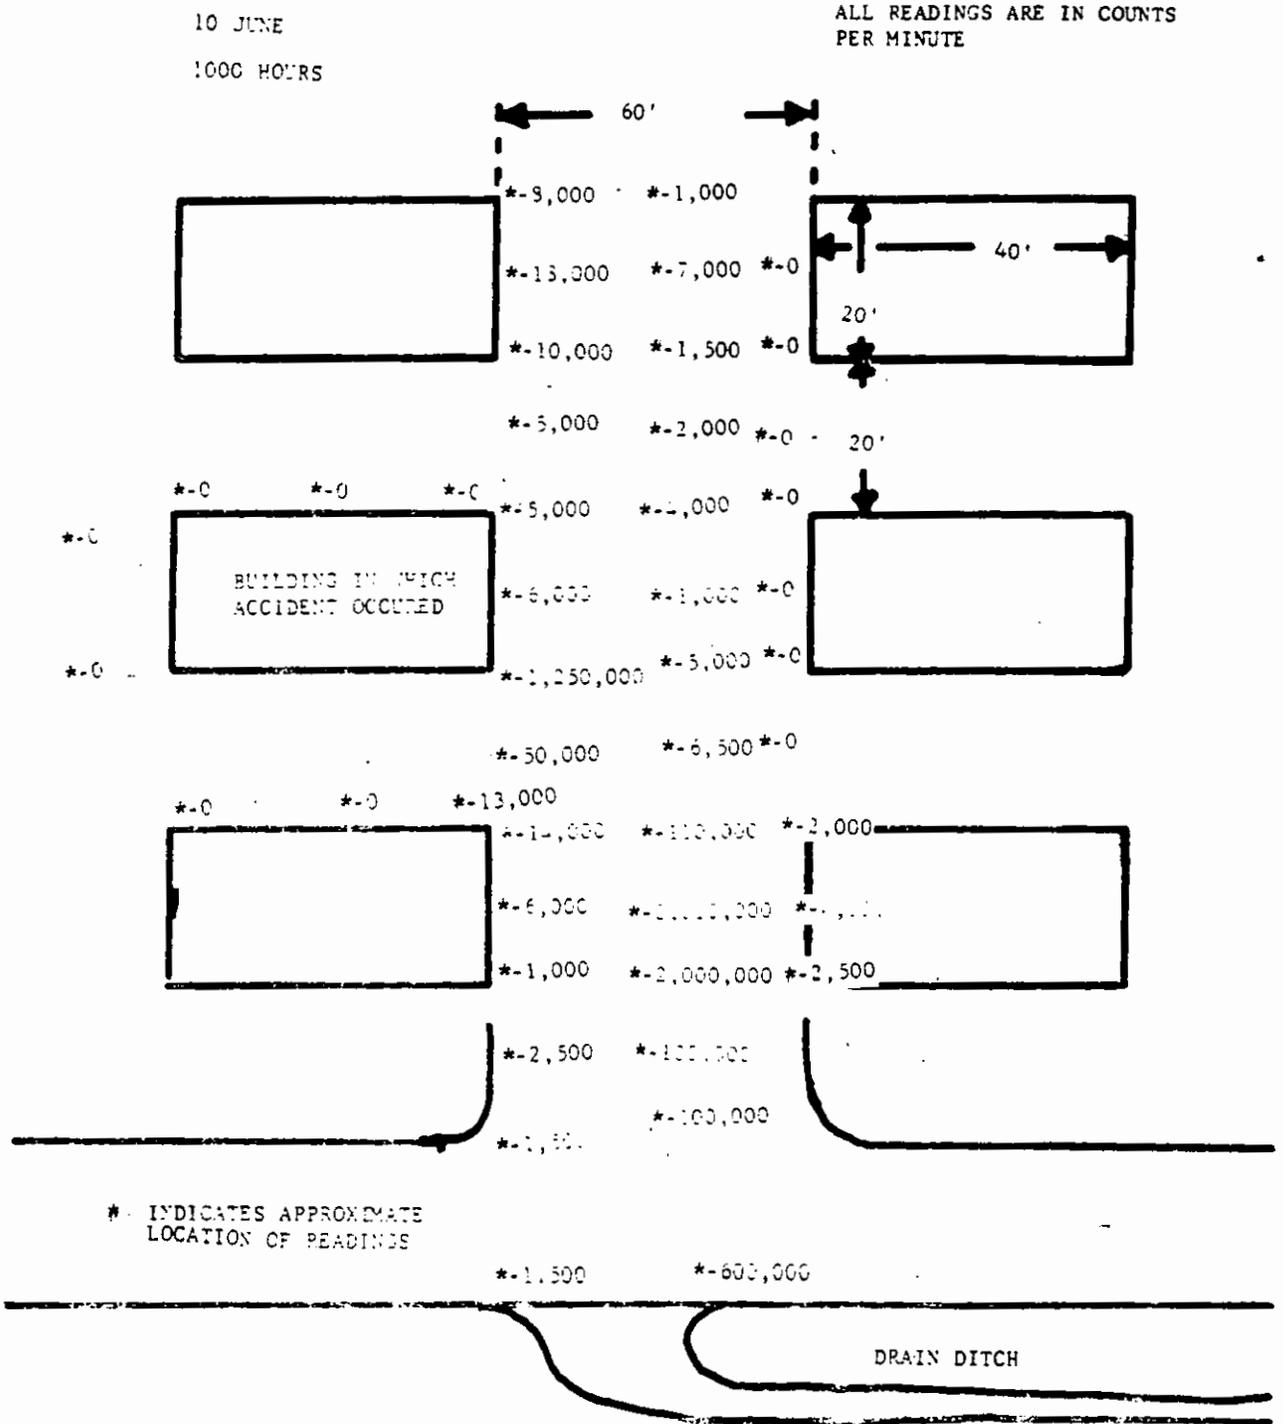
FIGURE 2. Monitoring Survey Results, 10 June 1960.

(6) On 10 June the entire area was agai  
was found that during the fire tar had melted and had s  
sections of the floor in thin layers. Several of the  
cated readings of over 2,000,000 CPM. The clean area  
zero (0) readings. The center of the road in front o  
also raised in contamination reading to 2,000,000 CPM  
2.) The entire area was again washed down and allowe  
remonitored a slight drop in contamination was found,  
of the roadway was still over the allowable limits. i  
completely dried, the inside of the shelter was painte  
A very thick layer of paint was applied. The outside  
painted, using brooms to spread the paint. A total o:

paint were used. When the paint had dried sufficiently to walk on, monitoring was again resumed. All areas that previously indicated high levels of contamination were effectively covered and zero readings were obtained. A few places on the fringe area indicated minor readings of 50-500 CPM. This reading was determined to be non-hazardous. The EOD personnel terminated operations at 2200 hours (EDST), 10 June 1960.

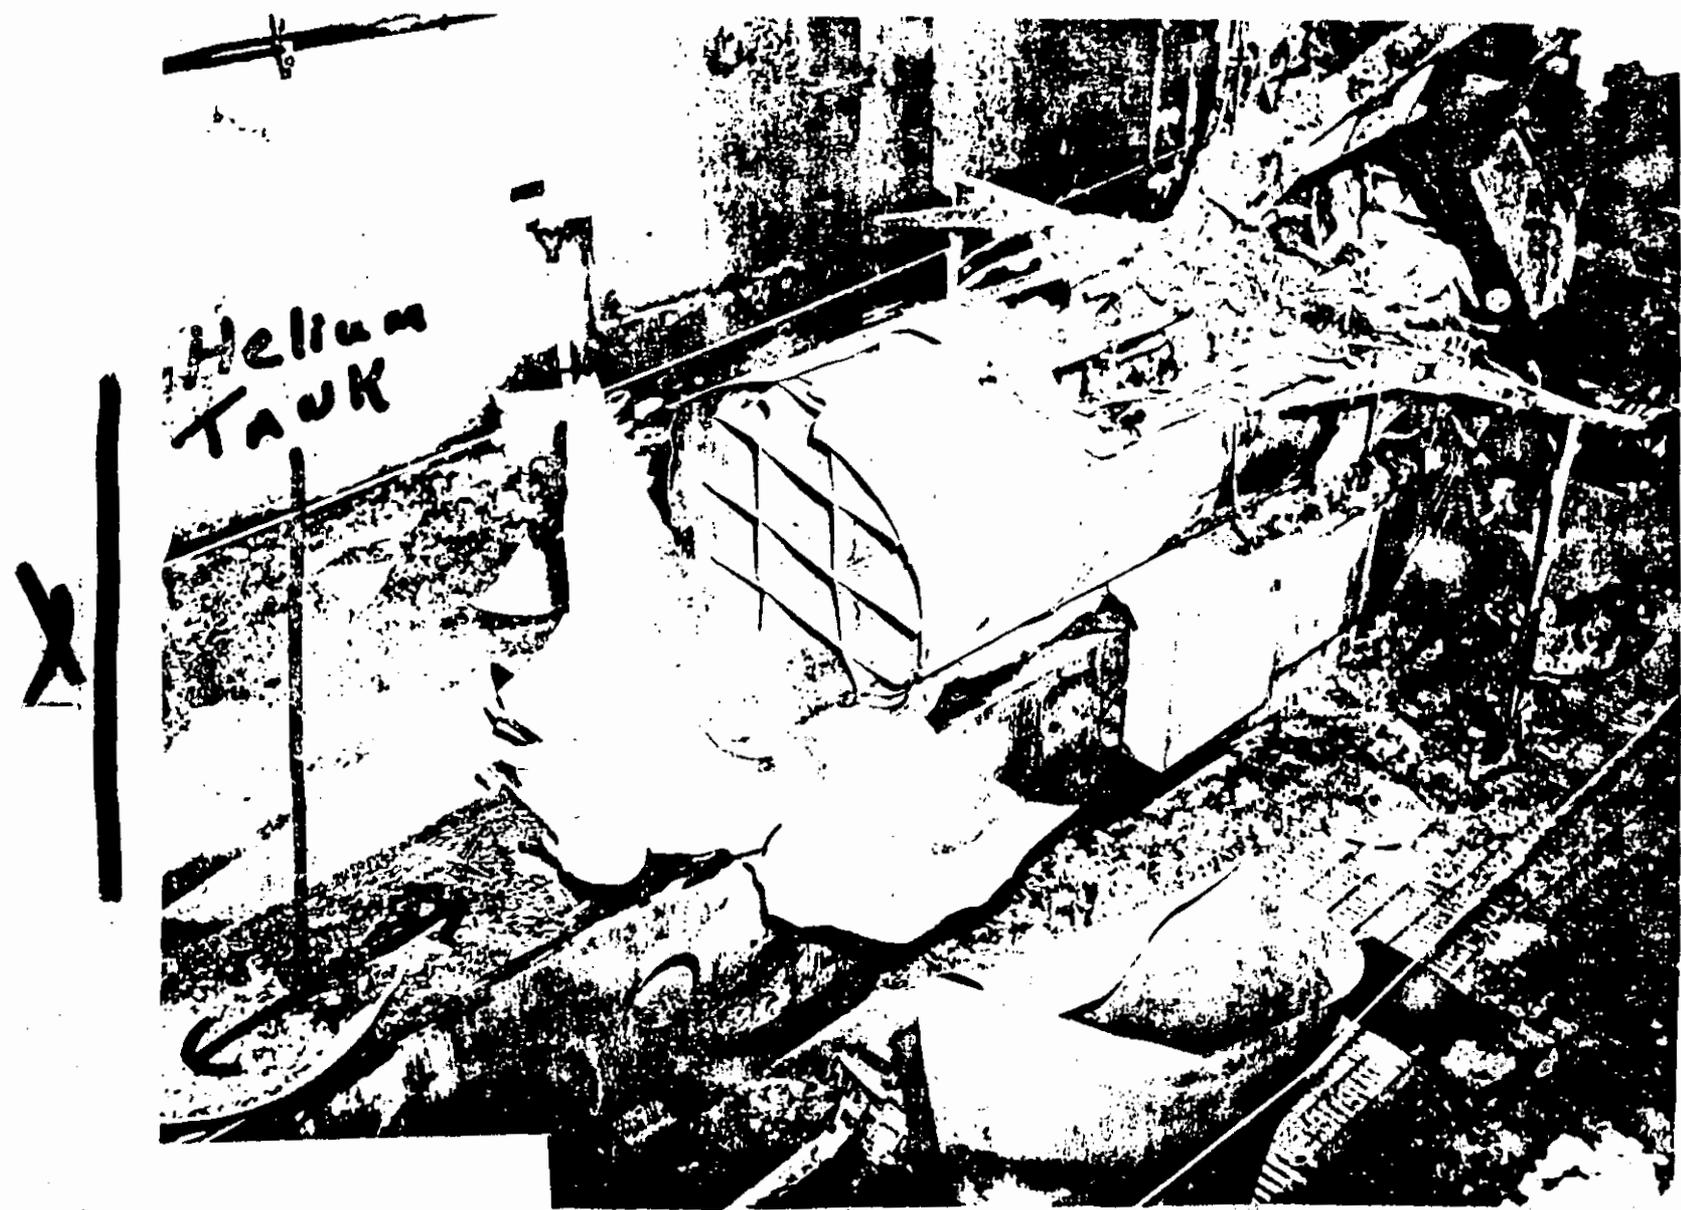
FIGURE 17. Helium Tank Location. Indications Point to Violent Rupture.

(9) Note Figures 3, 4, 5, 6, 7, 8, 9, 10, 11, 12, 13, 14, 15, 16, 17, 18, 19, 20, 21, 22 for extent of damage incurred at this incident.
